PENNSYLVANIA
TROUT LAKE DAM

NDI - PA 00769
PA DER 45-43

PHASE I INSPECTION REPORT
NATIONAL DAM INSPECTION PROGRAM

Name of Dam: Trout Lake Dam
County and State: Monroe County, Pennsylvania
Inventory Number: PA 00769

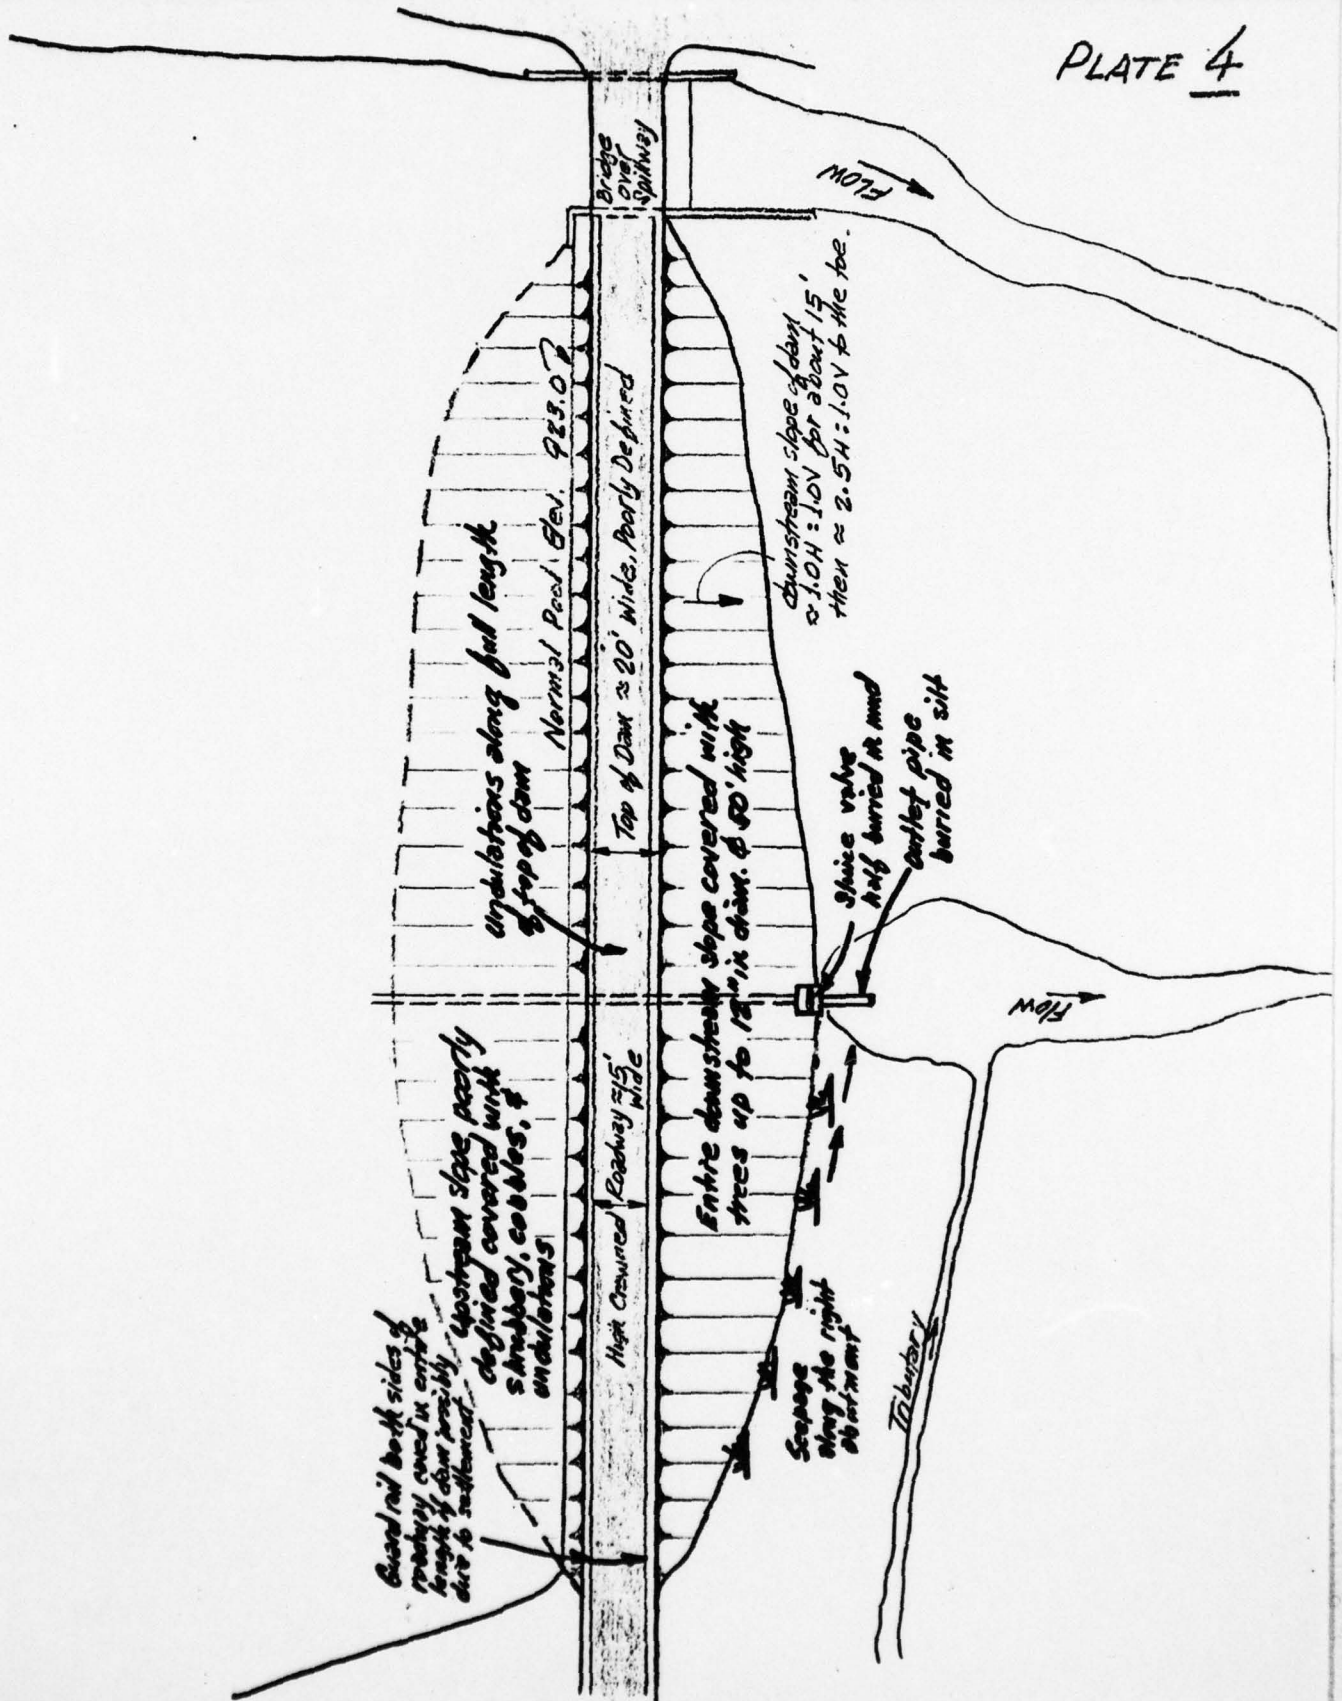
PLATE 4

3. The depressions along the upstream face, the seepage and discolored water at the toe of the earth embankment, and undulations of all of the embankment surfaces may be indicative of the migration of fine material through the embankment or foundation. A subsurface investigation should be initiated at several sections of the dam to include, but not be limited to, soil borings for determination of the composition and in situ properties of the embankment and foundation materials. The investigation should be supervised by a licensed professional engineer with experience in the design and construction of dams. Results of the investigation should be used to establish if the materials are satisfactory for the embankment as designed and constructed; and to detect possible fines migration.
